信毅輪船沉船

日期：2012/06/07

項目名稱：信毅輪船沉船影像檢查項目

目的：沉船檢查，水下攝影，檢查是否漏油，並回報高雄港務局

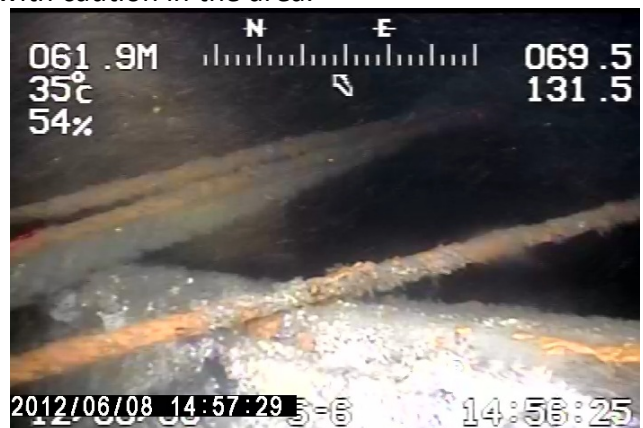
船裡管路是否漏油

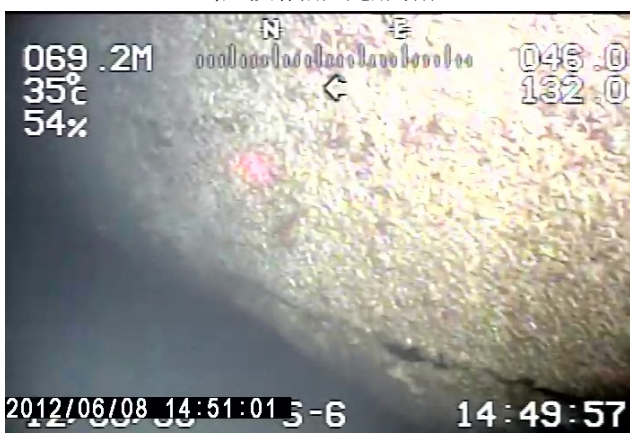
檢查船底是否有裂痕

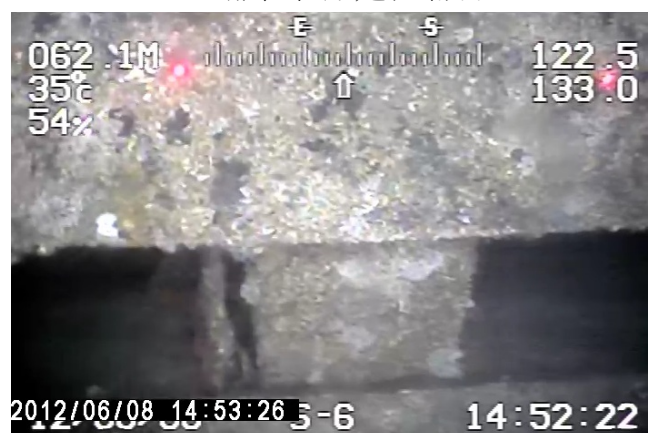
檢查船底是否有裂痕
